# LANDSLIDE STUDY USING TERRESTRIAL LASER SCANNER (LiDAR) ANALYSIS

P. C. Pesántez<sup>1\*</sup>

<sup>1</sup> University of Cuenca, Engineering Faculty, Cuenca, Ecuador - (pamela.pesantez)@ucuenca.edu.ec

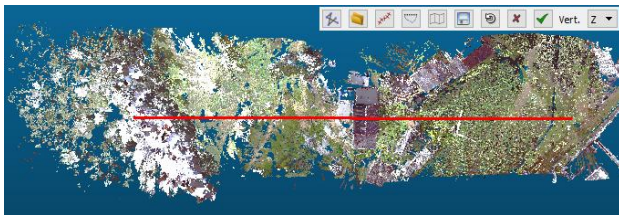
Obtaining the profiles is done with the CloudCompare extract cloud section tool as shown in Figure 5, the new point clouds corresponding to the extracted profiles are saved in the .las format for use in AutoCAD® Civil 3D.

Figure 5. Profile extraction process

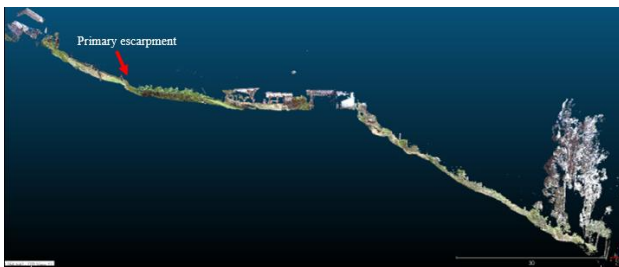
The profiles obtained in CloudCompare are exported to represent, locate and quantify the movements that the landslide has suffered as shown in Figures 6, 7 and 8.

Figure 6. Profile 1 exported to AutoCAD® Civil 3D

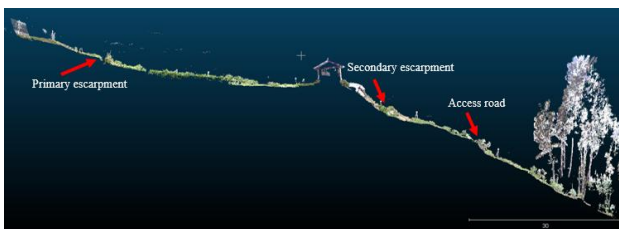
Figure 7. Profile 2 exported to AutoCAD® Civil 3D

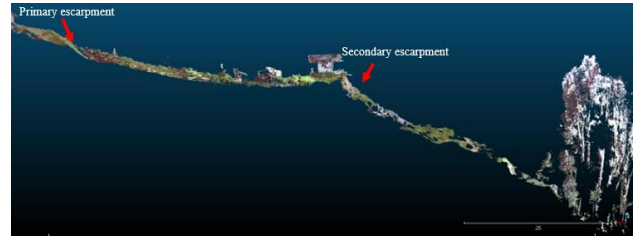
Figure 8. Profile 3 exported to AutoCAD® Civil 3D
