**Estudios sobre
Arte Actual**

**Número 4
Julio de 2016**

Lost heritage buildings in Cuenca-Ecuador: Historical analysis of the “Villa Roselena, in El Ejido of Cuenca”

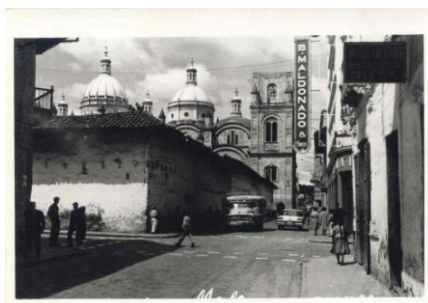
This is a colonial monastery with enclosure walls (no windows and doors) that closed the block located diagonally from the Cuenca’s Central Park: “Calderón Park”. In the 70’s, wide gardens and colonial buildings disappeared to make room for buildings with more than two floors without any value right in the middle of the Historical Center of city.

Fig.1. Enclosure wall of the Monastery “El Carmen de la Asunción”.
Source: Collection “Fundación El Barranco”

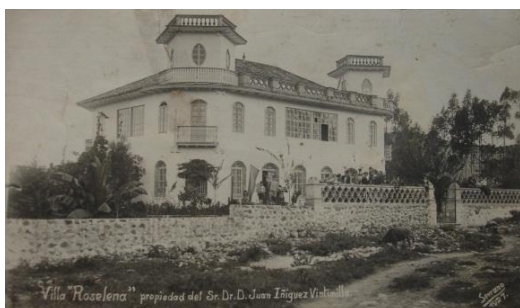
Fig. 4. La Villa Roselena.

photograph (Fig. 4), in which one clearly notices that the landscape around the mansion has a unique characteristic vegetation, without other buildings in its surroundings (“La villa Roselena” 1).

The walls of the Villa Roselena were constructed of adobe for the lower part and bahareque for the higher part. The walls have a width of 1,20m so that the constructive system could have been combined between bearing walls of adobe and partition walls of bahareque. The walls and the ceiling were almost completely covered with paintings (murals). The structure of the roof was of wood and covered by tiles.

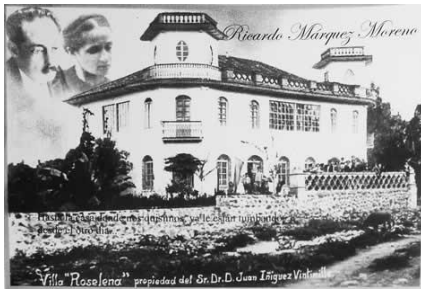
Fig. 5. The former Villa Roselena.
Source: Collection “Fundación El Barranco”

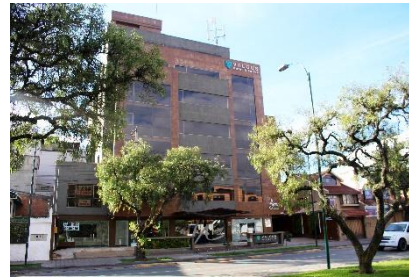
Fig. 6. The current building Valgus
Source: Rosa Pintado

At the death of Madam Rosa Elena Arteaga, the building stayed in hands of her heirs, who later on sold the property. The “villa Roselena” was demolished on May 1st 2008 and a new multi-story building “Valgus” took its place.
