## STRATEGIES FOR THE MANAGEMENT OF BUILT HERITAGE LINKED TO MAINTENANCE AND MONITORING. CASE STUDY OF THE SAN ROQUE NEIGHBORHOOD, CUENCA, ECUADOR

**KEY WORDS:** Heritage, monitoring strategies, maintenance, governance, documentation.

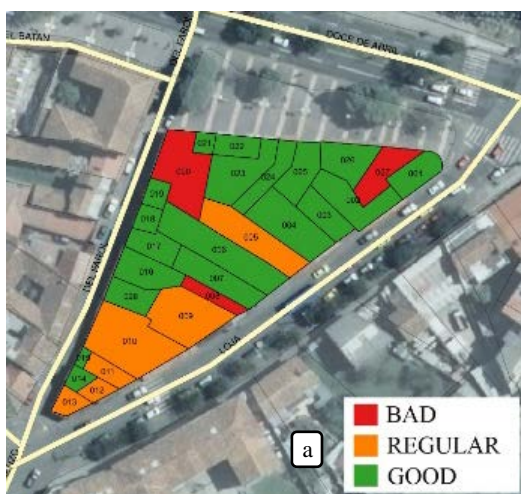
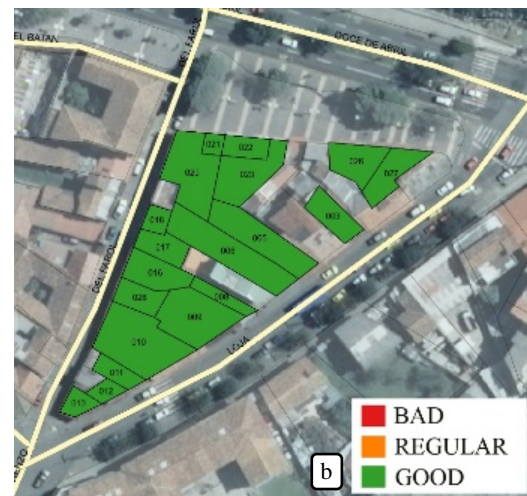
Figure 2a: The condition of the buildings in the Diagnosis phase, before the Campaign (2012). Source: vlirCPM project.

Figure 2b: The condition of the buildings in the Diagnosis phase, after de Campaign (2014). Source: vlirCPM project.

Figure 2 shows the change of the condition of the buildings to "good" as compared to their condition in the diagnosis and control phases.

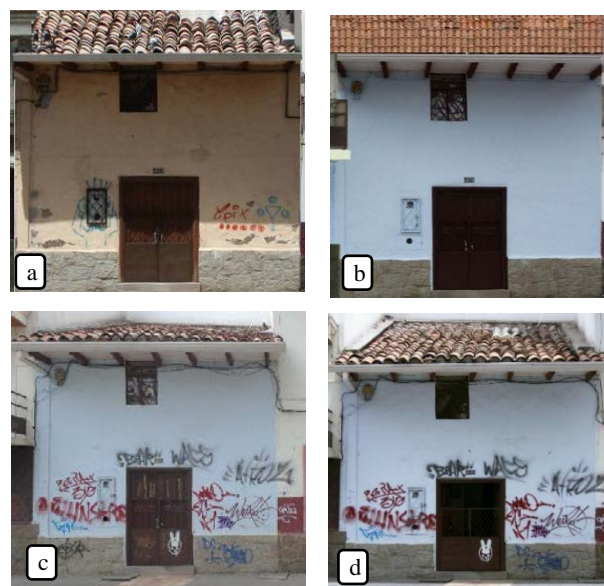
Figure 3: a) Before the Campaign (2012) b) After de Campaign (2014), c) monitoring (2016), d) monitoring (2017)  
Source: vlirCPM project

As part of the monitoring process of the façades carried out by the vlirCPM project, the sections facing the Av. 12 of April in the Square of the Farol are analyzed. In the diagnostic phase (2013) and after the execution of the campaign (2014), a photographic survey was carried out to present color proposals as part of the façade enhancements. During the monitoring and control phase, several visits were made to the site in March 2016 and January 2017. These visits showed that vandalism, in the form of graffiti, had negatively affected the appearance of the façades. Also a lack of daily maintenance by the owners was observed, which can be attributed to several factors: lack of resources, lack of interest, lack of ownership of their buildings. It is important to indicate that of the 9 buildings of the indicated section 30% has not had maintenance on their façades. As an example of the monitoring process, figure 3 shows a building and its deterioration due to a lack of maintenance.

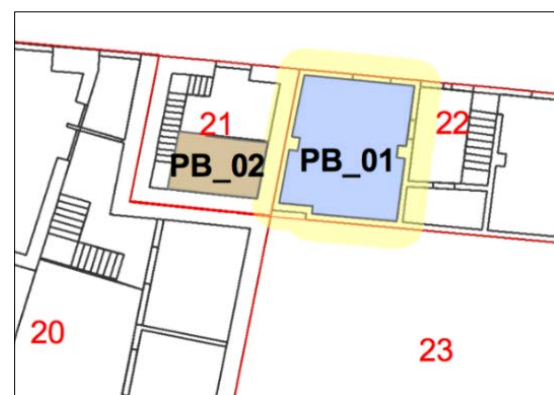
Figure 4: Damage in various elements in continuous environments. Source: vliirCPM project

Using the planimetric information, damage registers and their topological relationship, it is possible to identify environments that could require immediate intervention. This type of spatial queries trigger factors such as risk, based on the variables: damage, materiality and location, as shown in figure 4.

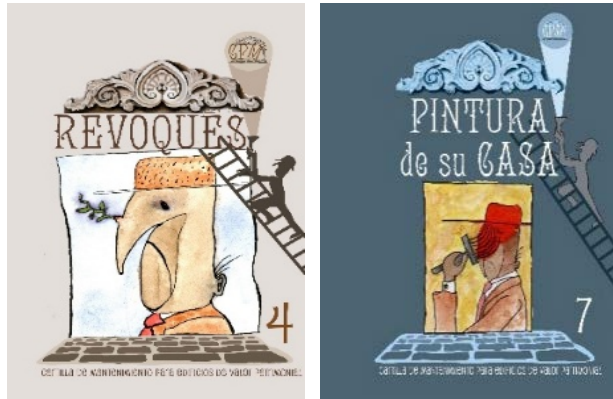
Figure 5: maintenance booklets  
Source: vlrCPM Project

The vlrCPM project (University of Cuenca) has produced 12 maintenance booklets (figure 5) focused on solving the most common damages in different building elements, such as: roofs, walls of adobe and bahareque, plaster, painting, etc. These booklets use every day language and are a tool to be used by the owners to help them with the monitoring of their buildings.
