Data in Brief

Dataset of copper pipes corrosion after exposure to chlorine

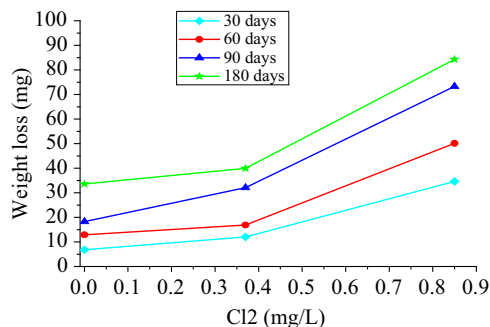
Fig. 2. Relationship of the weight loss with the concentration of chlorine.

With those data obtained from the weight loss of each coupon, a dispersion graph was made in which the trend of weight loss was observed as a function of the chlorine concentration for each exposure period. Weight variation presents a proportional relation with the chlorine concentration for the different exposure times (Fig. 2). While higher the concentration of chlorine in the water, the copper coupon tends to lose a large part of its surface generating a uniform variation in the coupons final weight.

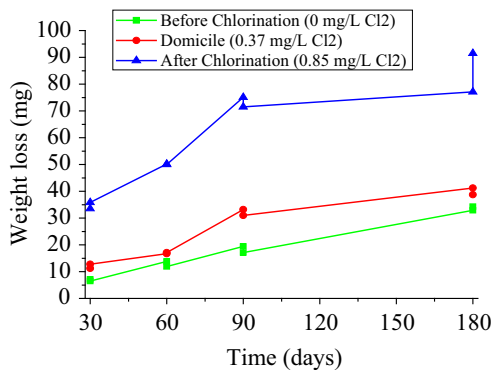
Fig. 3. Relationship of the weight loss with the exposure time.

The trend of weight loss was observed as a function of exposure time for different free chlorine concentrations (Fig. 3). The greater the exposure time of the coupon in water with certain mg/L Cl₂, the copper coupon tends to lose a greater part of its surface.

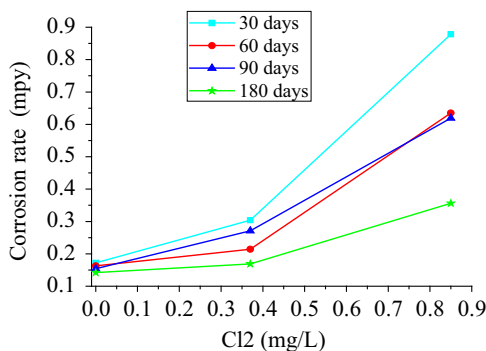
Fig. 4. Relationship of the corrosion rate with the concentration of chlorine.

When making a dispersion diagram, the proportional tendency of the corrosion rate was observed as a function of the chlorine concentration for each period of exposure (Fig. 4). Therefore, the higher the concentration of chlorine in drinking water, the copper pipes have a tendency to increase the rate of corrosion.

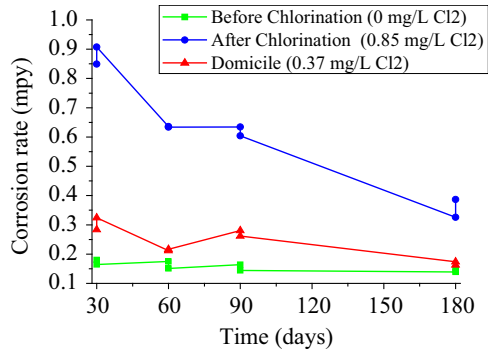
Fig. 5. Relationship of the corrosion rate with the exposure time.

The corrosion rate tends to decrease depending on the time of exposure (Fig. 5), due to the passivation that occurs on its surface that decreases corrosion [14].

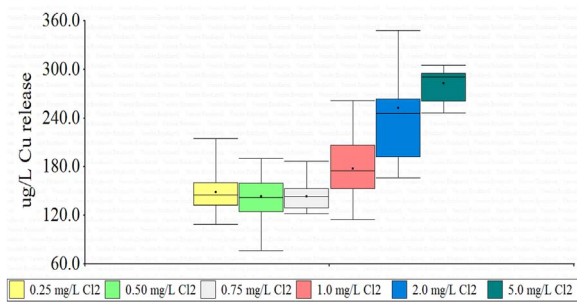
Fig. 6. Release of copper in drinking water at different concentrations of free chlorine.

Chlorine concentrations between 0.25 to 1 mg/L in water produce a slight variation in dissolved copper concentration. By increasing the chlorine concentration to 2 and 5 mg/L, a greater copper release is generated (Fig. 6).

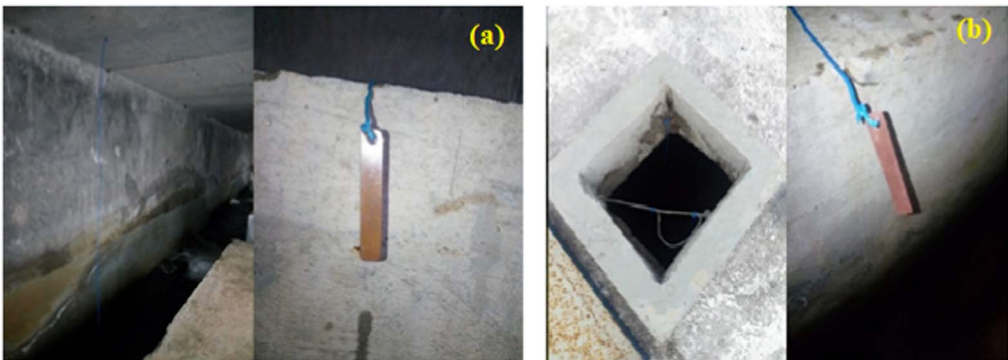
Fig. 7. Installation of copper coupons in the DWTP. (a) Before chlorination (b) After chlorination.

In the treatment plant, the coupons were immersed in a channel after filtration with 0 mg/L Cl₂ (Fig. 7a). Others coupons were also immersed in a tank after chlorination with an average concentration of 0.85 mg/L Cl₂ (Fig. 7b). The coupons were suspended with nylon thread to minimize changes in coupon composition and were left for 30, 60, 90 and 180 days.

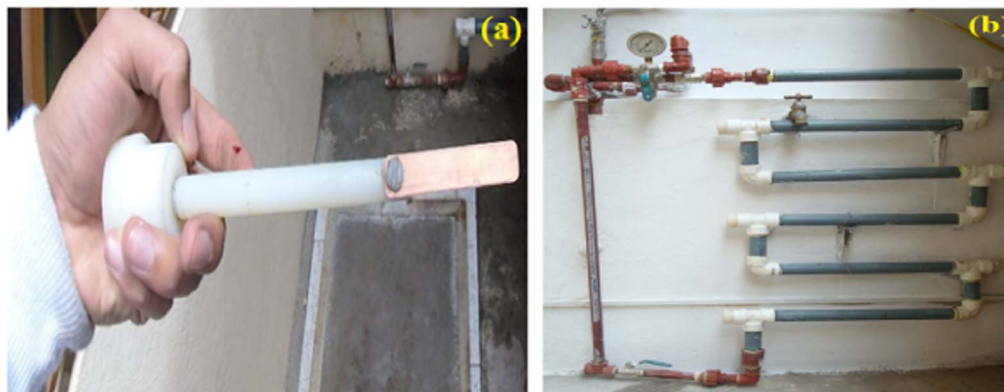
Fig. 8. Installation of copper coupons in a domicile (a) Coupon holder (b) Corrosion test rack.

The coupons were fastened in a coupon holder (Fig. 8a), finally the holder was installed in the corrosion test rack (Fig. 8b). The coupon was left exposed to water for 30, 60, 90 and 180 days. After each trial period, were removed the coupons from the corrosion test rack and subsequently cleaned

Coupons were made from rigid K-type copper pipes used by the municipal company of the Azogues city in the residential connections. Copper coupons were prepared out in accordance with the requirements of ASTM G1-03 [11,15]. The coupon holder was constructed of grilon with a diameter of 1.27 cm and a length of 7.62 cm (Fig. 8a). The corrosion test rack was constructed of materials that do not contribute to corrosion or cause an inhibition of corrosion. Therefore, 2.54 cm diameter PVC tubes were used. The proposed design presented six horizontal sections of 70 cm and six vertical sections of 20 cm. The right angles of the system were designed to insert the coupon holders (Fig. 8b).

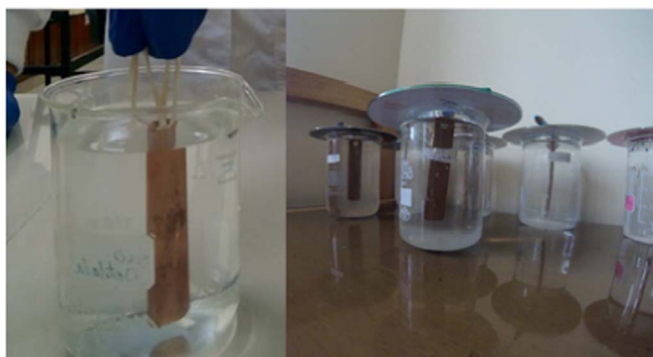
Fig. 9. Static immersion test Coupons submerged in calcium hypochlorite solution.

For the static immersion test, potable water with the chlorine concentrations prepared above was placed in 250 ml beakers, as shown in the Fig. 9. A pre-weighed copper coupon was placed in each beaker. The solutions were changed through the emptying and filling protocol in different time intervals. Solutions with concentrations of 0.25 mg/L and 0.5 mg/L of Cl_2 were changed every 48 h; concentrations of 0.75 and 1.0 mg/L Cl_2 every 72 h and high concentrations solutions 2.0 and 5.0 mg/L Cl_2 every 96 h; during a 30-day exposure time. The water resting times were used to evaluate the common scenarios of a pipe system [10–13]. In this way it was intended to maintain a chlorine concentration in each beaker.
