# The Importance of Preserving the Structural Concept of Historic Monuments: The Case of the Quinta San José in Azogues, Ecuador

F. Cardoso<sup>1</sup>(✉), C. Rodas<sup>1</sup>, and L. Barrera<sup>2</sup>

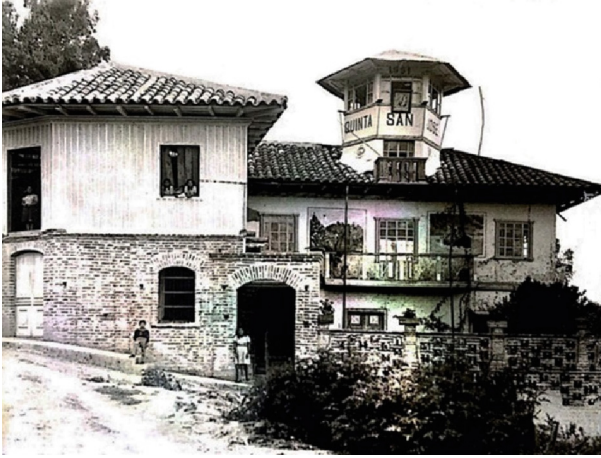
**Fig. 2.** Photograph of the facade of the house where the date 1931 can be seen at the top of the viewpoint. Source: Calle-Molina family archives. Courtesy of Teodoro Cordero Calle. n/d

The consolidation of the Quinta San José, benefits from several constructive impulses between 1915 and 1931, being this last year the one in which it enjoys greater completion and fullness, with a fundamental body that is constituted in the main element of the set: A large house of bahareque ennobled by moldings and ornaments of classic inspiration, with comfortable social spaces and an altana (or viewpoint) in which the initials of the owners stand out. Since the mid-twentieth century, the building has suffered progressive abandonment and since the twenty-first century it has been affected by “restoration” actions that aggravate its state of preservation. In 2018, restoration studies promoted by the Municipality of Azogues began, in order to return to the house its heritage values and structural consistency (Fig. 2).

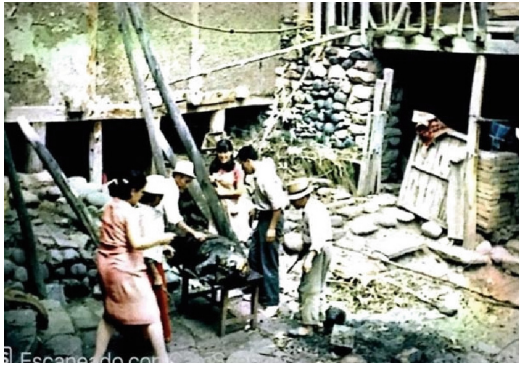
**Fig. 4.** Image of the construction technology applied. Source: Project report

is a mixed system, since it is composed of a wooden frame which is filled with cane covered with a mixture of mud and straw; in this system, each material fulfills a specific function: the wood constitutes the resistant soul of the bahareque construction, since with its horizontal and vertical pieces, it configures the frame that is braced and stiffened with the diagonal pieces; the cane serves as an additional reinforcement of rigidity of the wood frame and provides a solid and uniform base for the application of the mud layers; Finally, the mud and straw form the final layer that formally concludes the bahareque, their combination includes local materials with a low carbon footprint, but at the same time provides thermal and acoustic insulation, with efficient results for the climatic demands of this region of Ecuador (Fig. 4).

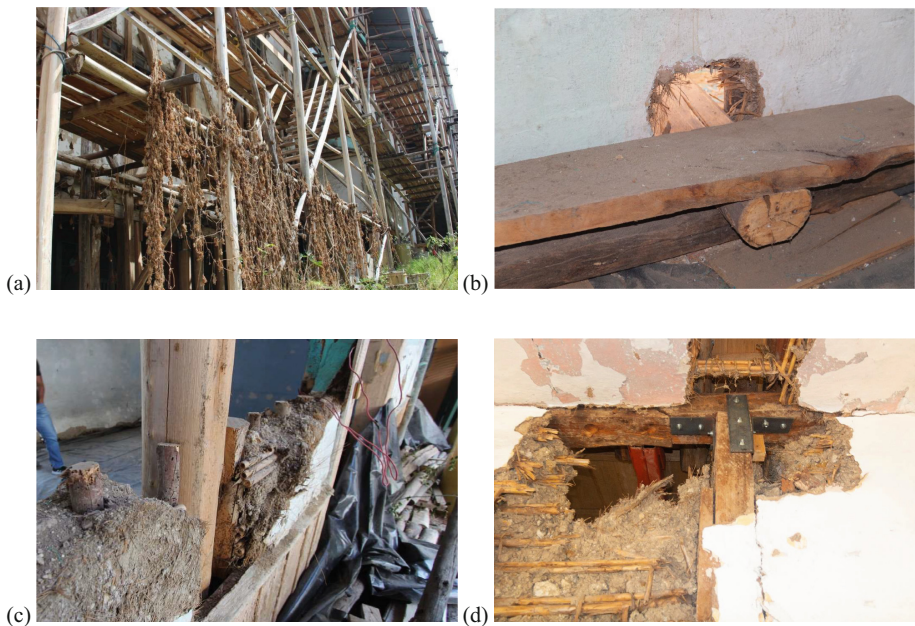
**Fig. 5.** (a) Scaffolding system affecting various parts of the structure. (b) Pathology structural intervention in walls of wattle and bahareque walls to support scaffolding systems. (c) Cutting and breaking of wooden parts. (d) Reinforcement of metal profiles. Source: Own (2020)

This scaffolding system (which instead of being self-supporting affected the vernacular structure) has been one of the biggest problems to be solved, since it has affected not only the general structural design but also the bahareque masonry elements, since walls have been perforated for their fastening, breaking the cane, loosening the mud, allowing the entry of humidity into the mud mass; However, the most aggressive part of these interventions has to do with the cutting and breaking of wood pieces, which prevents the guarantee of lateral stability in complete bahareque segments, resulting in the alteration of the integral geometry of the building.

At the foundation level, a voluminous reinforced concrete reinforcement has been included, a material foreign to the traditional construction system and of an irreversible nature. For its construction, risky excavations were carried out with the overthrow of the original adobe basement walls. However, reinforced concrete is not the only material that is inconsistent with the original construction system, since in most of the wooden joints, metal profile reinforcements have been inserted in an attempt to solve problems of deformation in the floor structures.

This intervention was not executed in a technical manner or with minimum delicacy, as these foreign elements are directly supported on the same beams that it is intended to reinforce, excessively stiffening the joints and increasing the weight that causes the deformations that should be attacked. This intervention breaks and profoundly disrupts the vertical continuity of the wooden pieces up to the foundation; it inserts foreign elements that cannot be hidden or concealed in the expressive context of the property, separates and eliminates vertical, horizontal and diagonal pieces of the internal frames of the bahareque panels, causing, as already mentioned, a considerable reduction in the structural elasticity of the bahareque originally entrusted to the bracing of the structural assembly and to the complementary cladding systems using local reeds (Fig. 5).

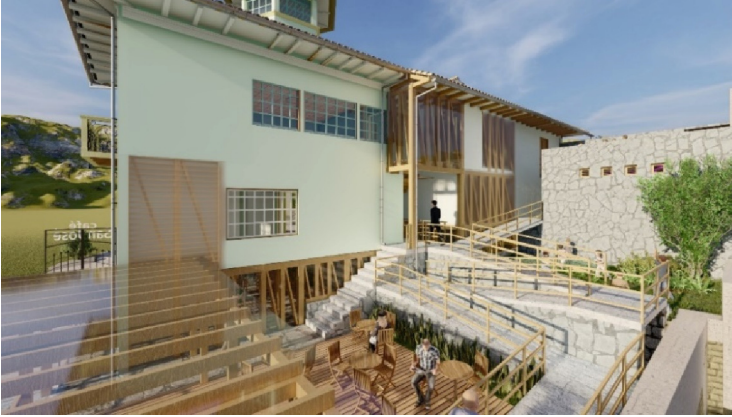
**Fig. 7.** Intervention proposal, reinterpretation of bahareque to replace severely damaged walls. Source: Own (2020)

Therefore, according to the project, there will be three ways to take on the challenge of progressively restoring the structural consistency of the Quinta San José, with regard to the bahareque structures that are part of the building: restoration, in the case of ascertaining an appropriate cohesion of the bahareque structures and the good state of conservation of the parts; renovation, if as a result of the exploration work it is determined that the bahareque panel has stability problems or has lost cohesion with the vertical wooden elements, then it is prudent that, given the impossibility of returning the structural cohesion of the walls with external accessories or prostheses, these are disassembled and rebuilt from the beginning; incorporation, the severely damaged or missing bahareque walls have been proposed as modern elements that close the spaces, with fine carpentry and abundant natural light. Thus, what is incorporated in the rear level of the first floor (towards the interior road), is a wooden structure inspired by the bahareque structures not only as an expression but as a structural proposal, which will open reflections, narrate the technology in a clear way and generate additional light to the internal environments of the Quinta.

The above-mentioned progressive intervention process from the bottom up will progressively remove the joints and other metallic elements that affect the structure, carefully remove the heavy scaffolding system arbitrarily introduced and thus, progressively return the “spirit” or structural concept to the building (Fig. 7).
